Quick Check Drive[®] **Inspection** Autonomous Alignment and Tread Depth for the Service Drive

Quick Check Drive[®] — A powerful autonomous alignment inspection system!

Quick Tread Edge® — **Touchless tread depth with** edge wear detection!

> Form 7632-TE-05, 09/19 Supersedes Form 7547-TE-05, 06/19

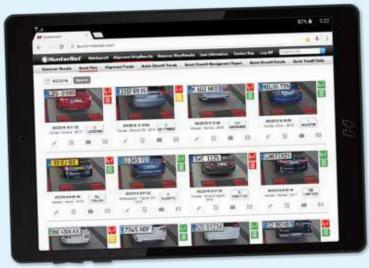
Shop Results — View and present inspection results from any internet connected device

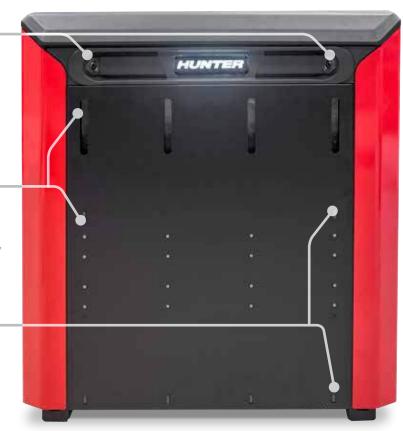
How It Works... As the vehicle drives through, cameras measure distances to the tire to calculate total toe and individual camber.

Hunter's patented system acquires up to 16 results. Measurement outliers are removed and the other results are averaged to provide utmost accuracy.

8 Cameras and _ 32 Laser Sensors

- ✓ Accurately inspect camber and total toe
- 16 measurements taken to increase accuracy
- Repeatable results

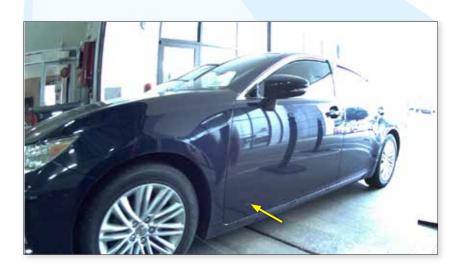
Use HunterNet® to quickly review vehicle images

- Intuitive body damage camera interface displays vehicle information and date of service
- Four cameras capture an average of 10 images each
- ✓ 15-day image storage standard
- Premium 90-day storage package available

Using the same built-in high-definition cameras, the body damage cameras enable your dealership to capture 40 or more images per vehicle in the same time it takes to check wheel alignment.

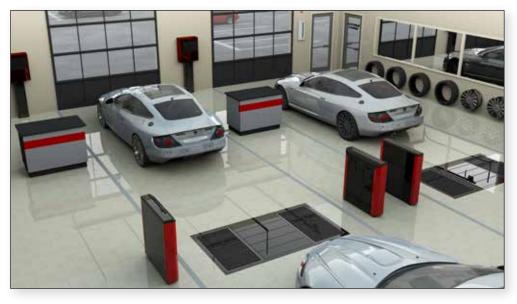
Flush-Mount Quick Tread Edge[®] (with alternate WU572 console)

- Smooth approach
- Zero obstructions
- ✓ Compatible with Quick Check Drive[™]
